## **“Full” Reserve Study**

**Mercer Park**

**Bellevue, WA**

**Report #: 11700-0**

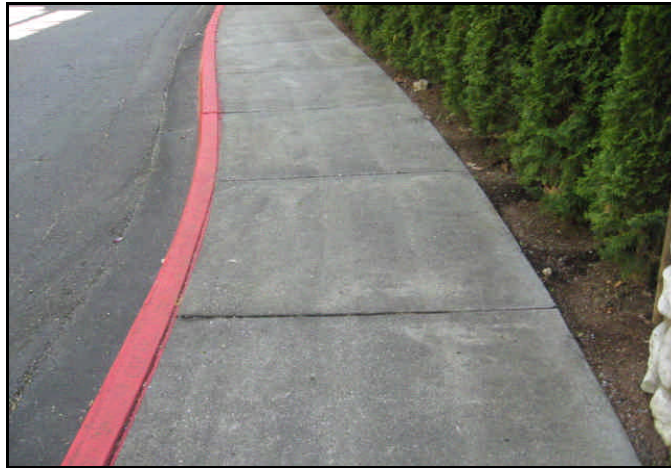
Repair any trip and fall hazards (1/2" or larger displacement) immediately to ensure safety. As routine maintenance, inspect regularly, pressure wash for appearance and repair promptly as needed to prevent water penetrating into the base and causing further damage. Monitor tree roots nearby; consult with arborist for best practice.

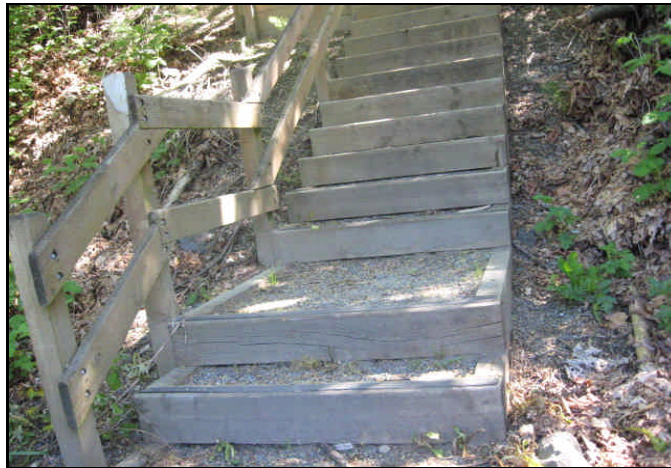
With ordinary care and maintenance there is no predictable expectation for total replacement. However, in our experience as the community continues to age, some periodic larger repair needs will likely emerge. Costs for periodic partial repairs are projected to be too small for reserve funding (use maintenance funds). No reserve funding suggested.

As routine maintenance, inspect regularly and perform any needed local repairs promptly as general maintenance expense. Ensure that tread connections are tight, secure and slip resistant. Paint components regularly along with building exteriors.

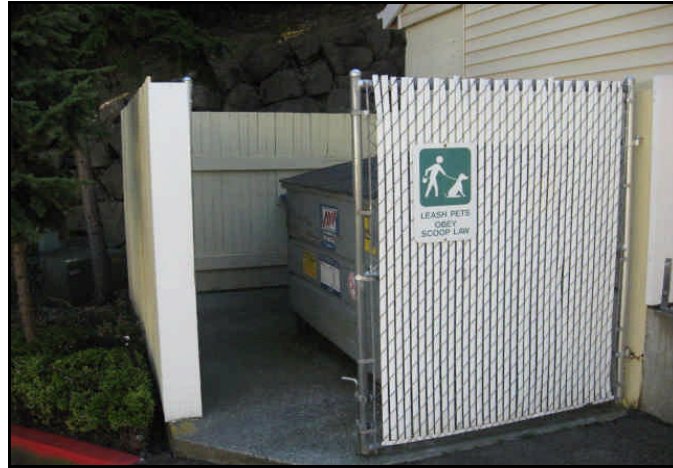
**Evaluation:** Trash enclosure typically had painted wood fence on three sides. The fourth side was a chain link gate with plastic slats. Fair condition noted with no significant damage/deterioration observed.

Clean, paint and inspect as general maintenance item or along with larger building projects, not as separate reserve project. Due to high use/abuse, plan to replace as shown here.

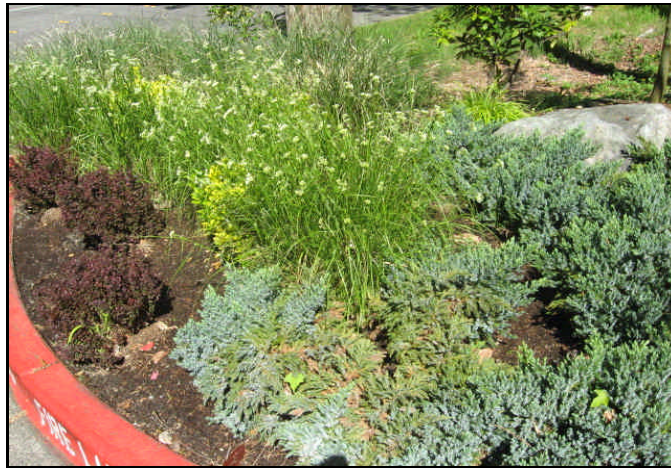
NOTE: Some areas of planting beds are within six inches of the siding. Building code requires minimum of six inch clearance between ground and the siding to help prevent insect and water damage of the structural wood walls beneath the siding. We suggest having the landscapers re-grade adjacent to the building as required to obtain a minimum of six inches clear, although eight inches to a foot would be better.

This component can be used to supplement the operation landscape budget for larger cost projects that occur less frequently than annually. These type of projects can include tree trimming, major replanting, and bark or mulch replacement.

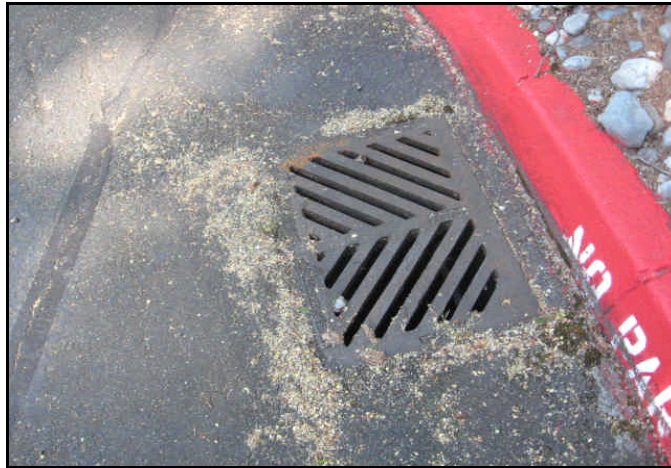
No predictable time frame for large-scale repairs/replacement at this time. No reserve funding suggested.

As routine maintenance, inspect regularly, keep drains and grates free of debris and free flowing to ensure water drains as intended. Evaluation of drainage can include visual review of the interior of the drain lines by video using a remote miniature camera. Clean out the drain lines as often as needed, to prevent a decrease in drainage capacity. Repair as needed. Utilize mobile evacuator service if needed.

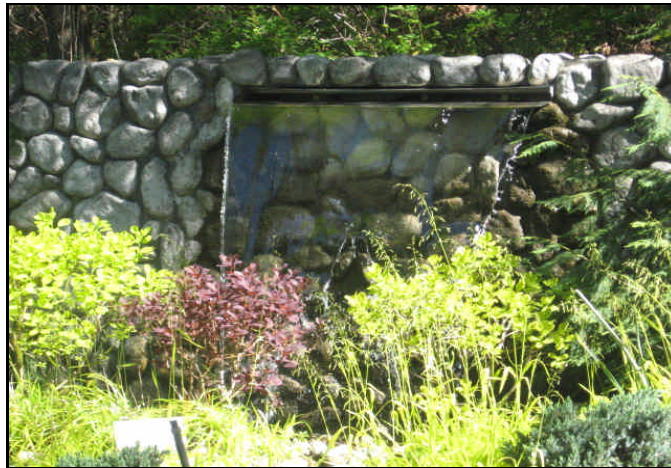
Pumps typically have unpredictable service life and possibility to rebuild; individually lower cost and difficult to predict timing thus does not merit reserve funding. Beds appear to be low maintenance with no predictable large scale refurbishing anticipated at this time. Overall, no components in this area appearing to merit large scale reserve funding.

Water features tend to be problematic. If problems become known and estimates for repairs are given, they can be added to a future reserve study. We recommend regular professional inspections to ensure waterproofing measures and prompt repair as needed.

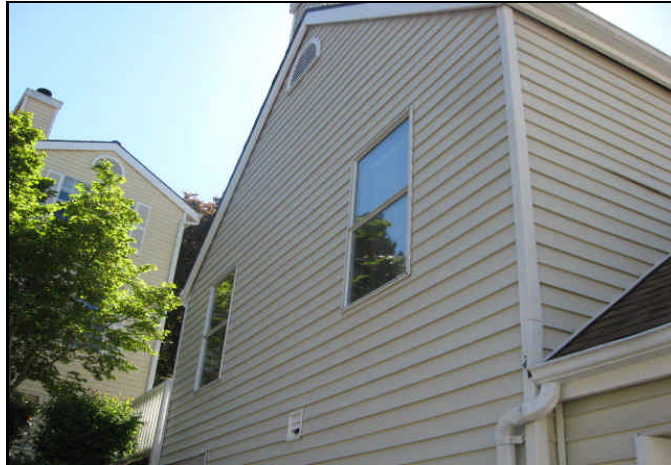
Cost for power washing is factored below. Timing of washing, if any is at the board's discretion.

Clean vinyl siding as needed to maintain appearances. When washing be careful to not spray high-pressure water beneath the vinyl. Two types of washing are typically available. Power washing is the least expensive. Hand washing is also available. In our experience, the condos have both types of washing reported that they preferred the hand washing, as it was a better job even though it costs more.

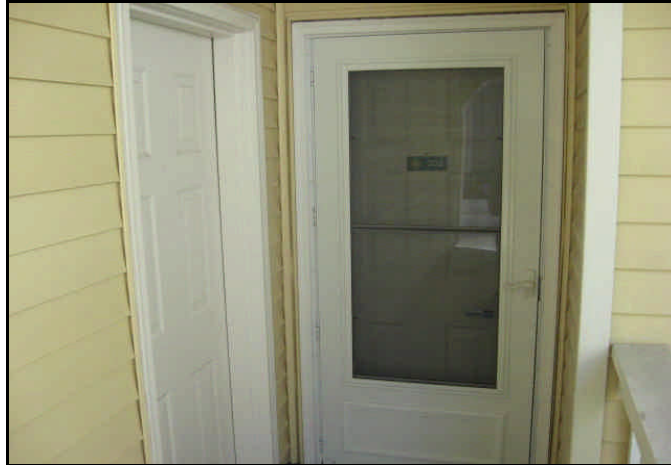
No predictable large-scale repair or replacement of doors. No reserve funding suggested.

Individual unit entry doors are expected to receive limited use (wear and tear). Door painting is included as part component #525. Inspect periodically and repair as needed to maintain appearance, security and operation with maintenance funds. Touch up paint as needed between painting cycles.

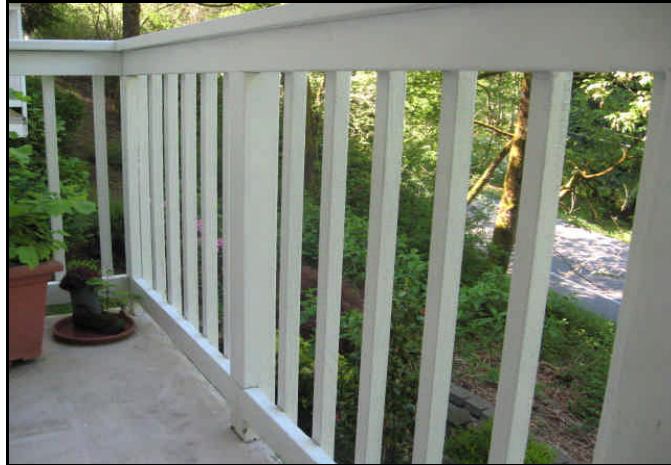
We suggest reserve funding for regular intervals of total replacement as indicated below. Evaluate rail system as remaining useful life approaches zero years and adjust life accordingly.

As routine maintenance, railing connections should be inspected at least annually for structural and/or waterproofing issues. Repair promptly as needed using general operating/maintenance funds.

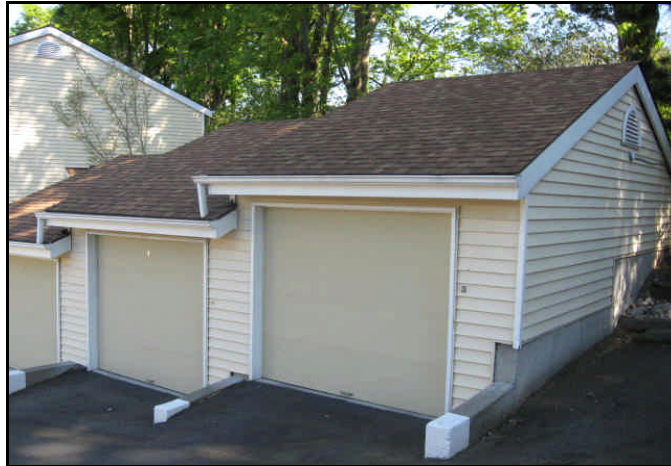
Evaluation: The components (roofing siding) of the garage structures is included as part of components # 500 Roofing and #520 Siding: Vinyl.

No separate reserve funding required.
