## **“Full” Reserve Study**

**Mercer Park**

**Bellevue, WA**

**Report #: 11700-0**

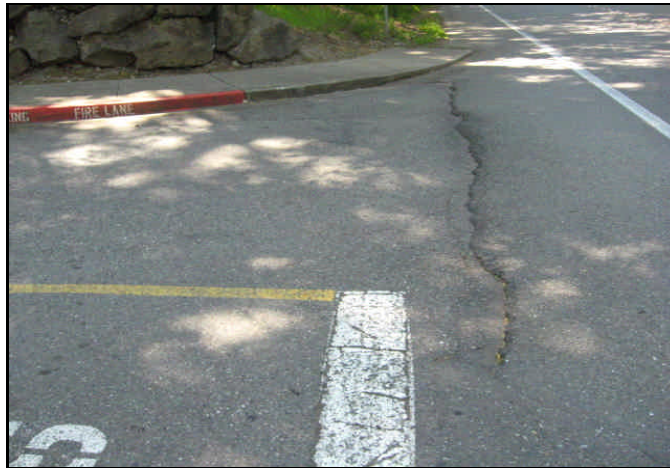
Useful Life:  
30 years

Remaining Life:  
5 years

Best Case: \$131,000.00

\$1.60/Sq Ft, Lower allowance to resurface (overlay)

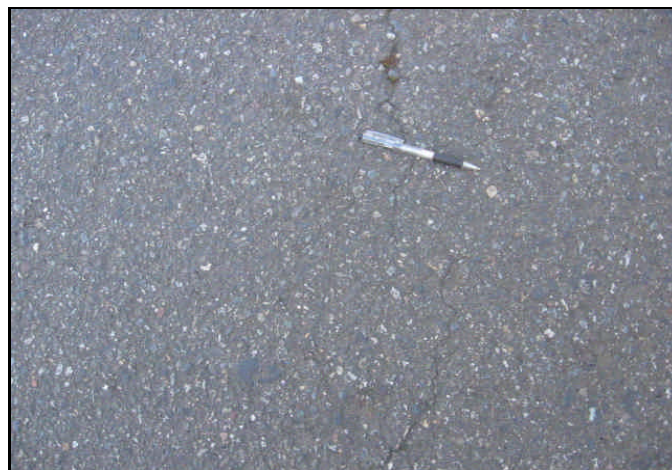
Useful Life:  
5 years

Remaining Life:  
0 years

Best Case: \$16,400.00

\$0.20/Sq Ft, Lower allowance to clean/seal/stripe

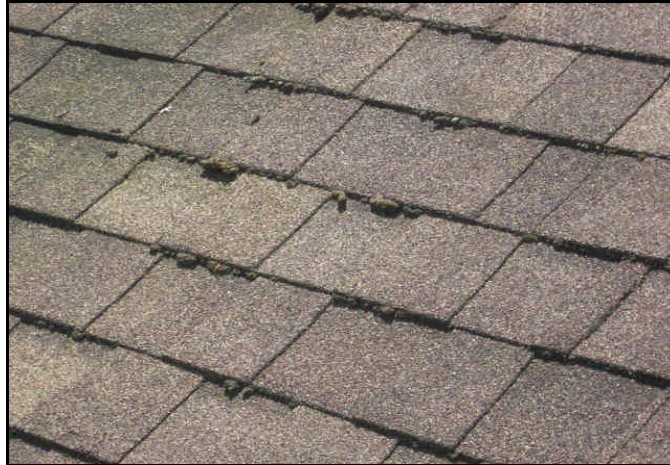
Useful Life:  
30 years

Remaining Life:  
8 years

Best Case: \$385,000.00

\$3.50/Sq Ft, Lower allowance to remove and replace roof

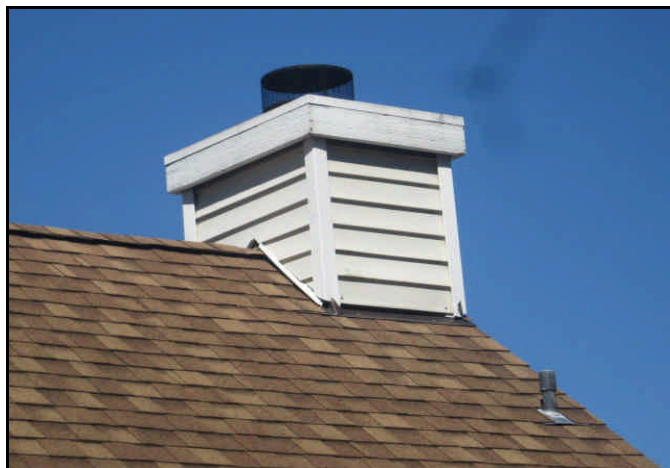
Useful Life:  
30 years

Remaining Life:  
8 years

Best Case: \$40,900.00

\$500/ea chimney cover and \$130/ea flue cap, Lower allowance to replace

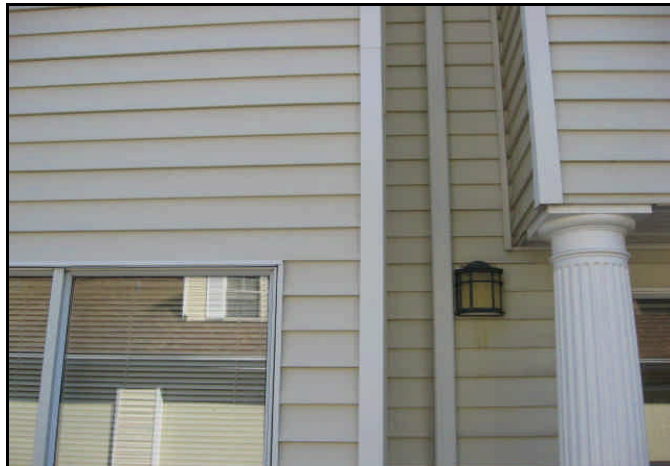
Useful Life:  
40 years

Remaining Life:  
16 years

Best Case: \$1,100,000.00

Worst Case: \$1,460,000.00

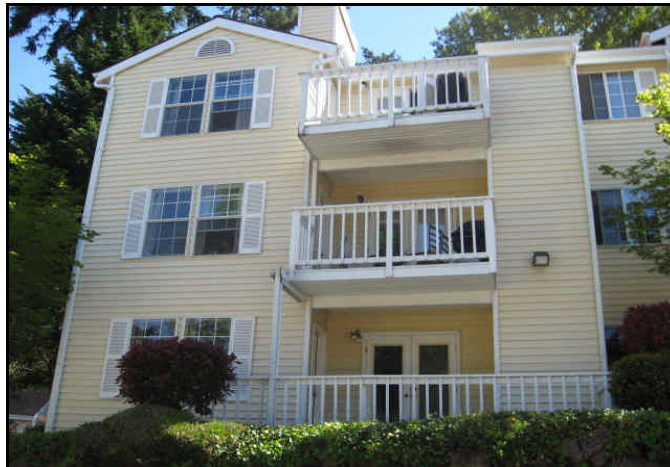
Useful Life:  
8 years

Remaining Life:  
3 years

Best Case: \$48,800.00

\$400/dwelling (x122), lower allowance to prep and paint

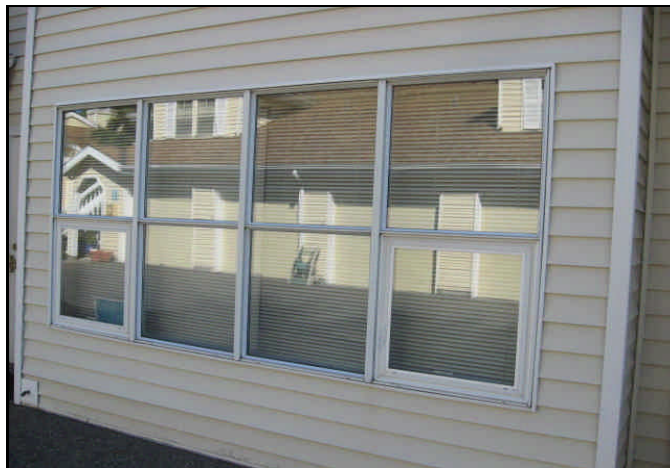
Useful Life:  
40 years

Remaining Life:  
16 years

Best Case: \$477,000.00  
\$900/window, lower allowance to replace

Worst Case: \$636,000.00  
\$1,200/window, higher allowance to replace;  
upgraded

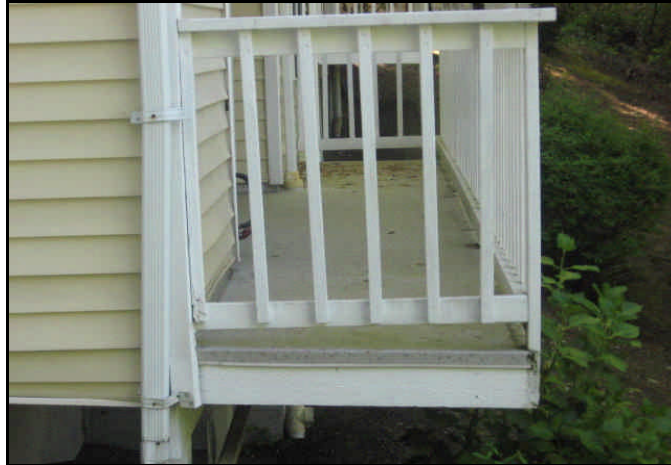
Useful Life:  
12 years

Remaining Life:  
0 years

Best Case: \$24,000.00

\$12/Sq Ft (x 2,000), Lower allowance to replace with pvc membrane

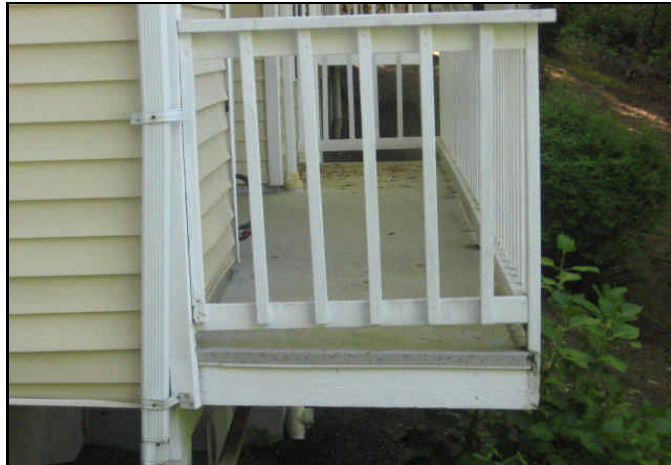
Useful Life:  
12 years

Remaining Life:  
6 years

Best Case: \$24,000.00

\$12/Sq Ft (x 2,000), Lower allowance to replace

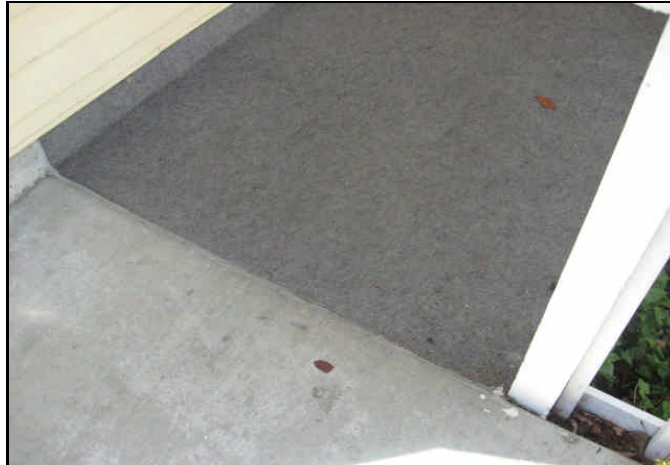
Useful Life:  
12 years

Remaining Life:  
0 years

Best Case: \$38,400.00

\$12/Sq Ft, lower allowance to replace with sheet vinyl

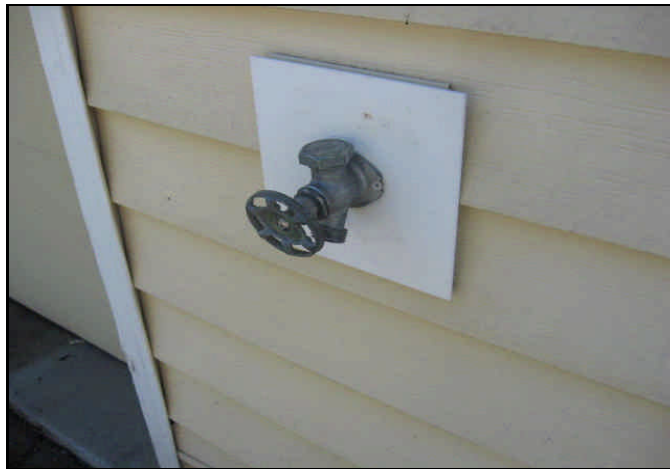
Some types of piping used historically are known to be life limited. Manufacturing defects become apparent from time to time and certain site conditions (e.g. galvanic corrosion, certain minerals in contact with piping, chemical reactions, etc...) can contribute to premature deterioration of plumbing system. The Association reported no known large-scale systemic or defective problems with the plumbing system. If there are concerns about possible problems, have a qualified plumber provide an overview of your system design, materials, and any areas of high risk.

Useful Life:  
0 years

Remaining Life:  
0 years

Typically, if installed per architectural specifications and local building codes, without defect, there is no predictable time frame for large-scale repair/replacement expenses within the scope of our report. Treat minor repairs as ongoing maintenance expense. If leaks, poor flow, sediments, defective material and/or installation become evident, have qualified plumber and / or engineer inspect closely and develop scope of any repair/replacement needed.
